4. TITLE (and Subtitle) MOISTURE DETECTION IN ROOFS WITH CELLULAR PLASTIC INSULATION—WEST POINT, NEW YORK, AND MANCHESTER, NEW HAMPSHIRE	5. TYPE OF REPORT & PERIOD COVERED

The study was conducted under DA Project 4A762730AT42, Design, Construction and Operations Technology for Cold Regions, Task D, Cold Regions Design and Construction, Work Unit 015, Infrared Inspection of New Roofs Prior to Acceptance.

**MOISTURE DETECTION IN ROOFS WITH CELLULAR PLASTIC  
INSULATION - WEST POINT, NEW YORK, AND MANCHESTER, NEW HAMPSHIRE**

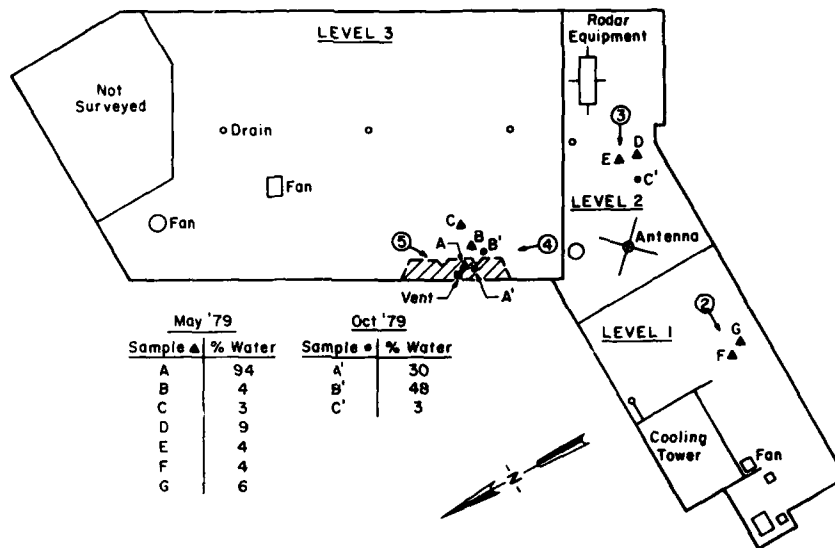
Figure 1. Plan view sketch of Building 753, West Point. For this and all other building sketches in this report, a circled number with an arrow indicates the location and viewing direction of a particular figure.

During the May and October surveys the thermal image of each level of the roof of Building 753 (Fig. 1) was mottled (i.e. with thermally light and dark areas blending into one another). By scraping the gravel cover and taking samples F and G (Fig. 2) in May we determined that the mottling was caused by varying gravel thicknesses and not wet insulation. Thick layers of gravel store more solar heat and remain warmer longer than thin gravel layers. Figure 2c, although mottled, does not have as pronounced mottling as Figure 2a, indicating less solar effect in October. The two black areas in Figure 2c were caused by patches at F and G.

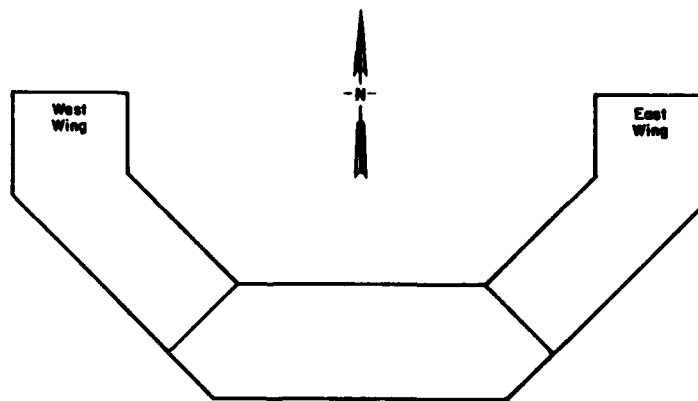
Figure 11. Section A, Building 667.

of the west and east wings of section A, which are shown in plan view in Figure 11. The west wing roof membrane was installed prior to December 1977 and the east wing membrane was installed prior to May 1978. Due to some unfinished work, the warranty for the roofs of these wings did not commence until December 1978.

Several thermally bright areas were found on each wing. Core samples showed that they were areas of wet insulation. Most of this moisture can probably be traced to flashing problems. The counter-flashing shown in Figure 12 was not installed until six months after the roof membrane was finished. When the flashing was finally installed, the sealant and bond-breaker rod between the flashing and the wall began to fall out and had to
